RE: Site Inspection, Wembco, Larry Allred Site, S/047/068, Uintah County, Utah

Date of Inspection: May 22, 2003  
Time of Inspection: 5:00 to 6:30 p.m.  
Conditions: Mostly clear, 80's  
Participants: Larry Allred (Operator), Paul Baker (DOGM)

**ATTACHMENT**  
**Report Date: June 9, 2003; Inspection Date: May 23, 2003**  
**Photographs**  
**S/047/068, Larry Allred Site, Wembco, Inc.**

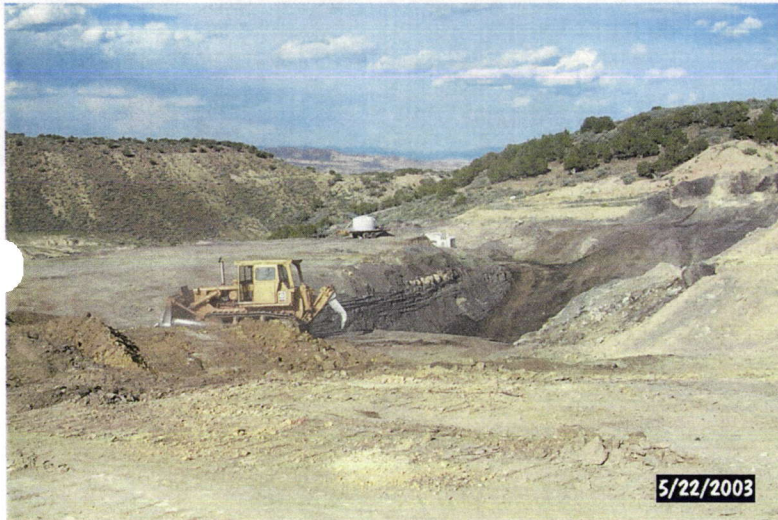
The mine was active at the time of the inspection. I took GPS information for later mapping for five areas: 1) The mine pit itself (Photo 1). 4.38 acres. This area is called "WEMBCO Mine" on the attached map. 2) An area west of the mine where there has been some disturbance but no major excavations. 0.76 acres. Called "reclaimable area." 3) An area it appears the operator has used to recycle asphalt (Photo 2). 0.64 acres. Called "Recycling area." 4) An area into which the operator brings asphalt from the mine and mixes it with rock with no other processing. 0.48 acres. Called "Mixing area." 5) A processing area that includes the operations in number 4 and also a batch plant where the asphalt is heated and mixed with rock before being sold. 2.93 acres. "Called Processing" on the map.

**Photo 1. The mine pit area. The processing areas are to the right of this photo.**

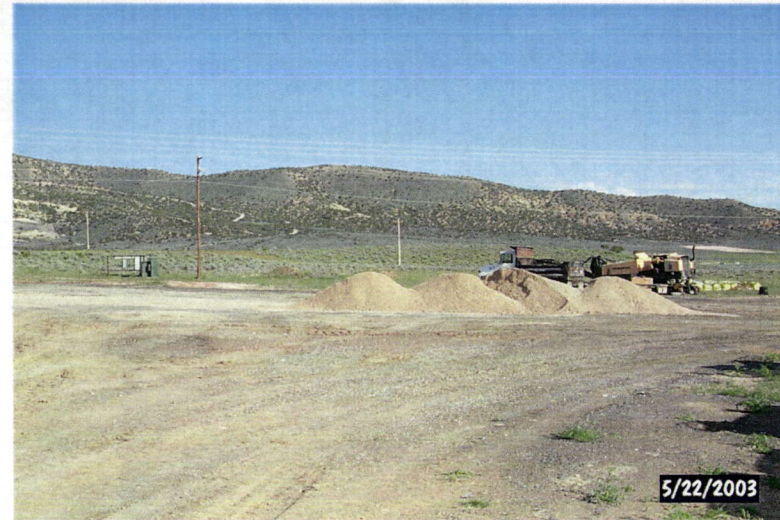
**Photo 3. This is the area where asphalt is mixed with rock after the asphalt is first brought out of the mine.**

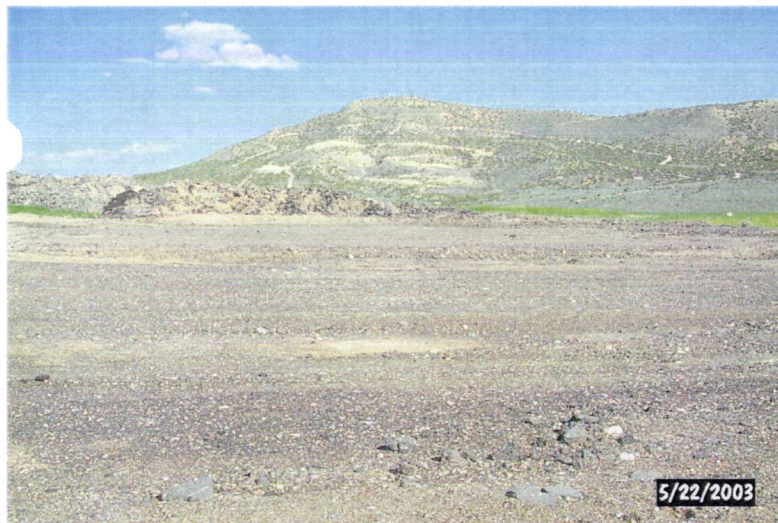
**Photo 2. The asphalt recycling area. At the time of the inspection, there was little asphalt stored here.**

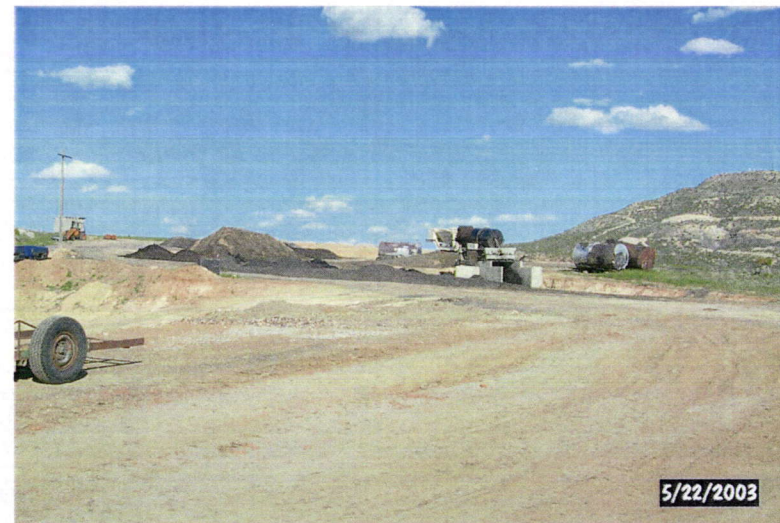
**Photo 4. In this area, the asphalt is heated and mixed with rock.**

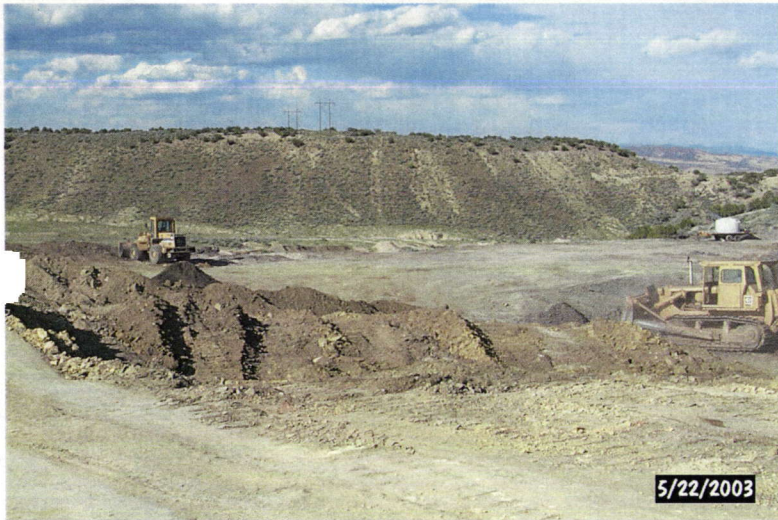
During the inspection, overburden was being dumped off a slope north of the mine (left center of Photo 5—the front end loader). There is a road a few feet from the waste dump. Some of the material being dumped looked like it might be soil, but I was not certain.

**Photo 5. The mine area with the front end loader on the left side of the photo placing overburden over the edge of an embankment.**

The operator needs to ensure that overburden being dumped in the area north of the mine does not roll onto the road and potentially endanger someone driving on the road. If it is necessary to continue dumping material in this area, a berm or other barrier may be needed to keep overburden from getting on the road.

The operator also needs to be sure soil is salvaged and is not mixed with overburden.

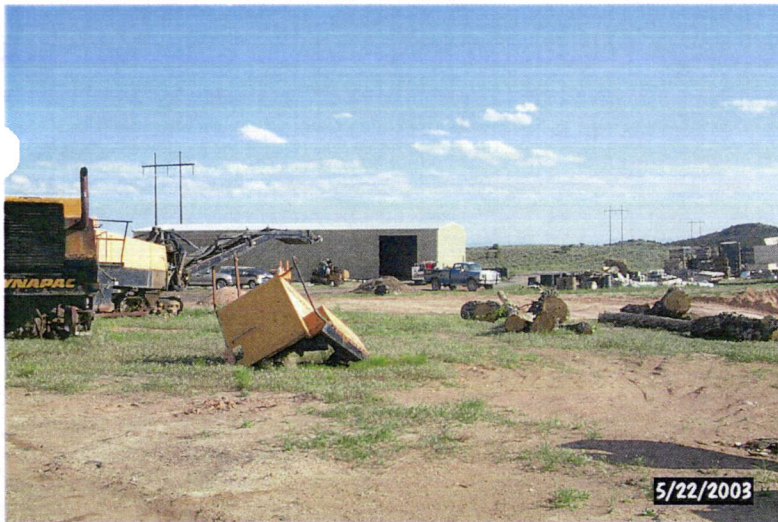
I did not take GPS readings for the area of an adjacent building which was included in the GPS measurements done for the previous inspection (Photo 6). The reason for not including this building was that Mr. Allred said it was owned by another company (Perma Patch).

**Photo 6. This building was not included in the GPS mapping.**

Mr. Allred told me the building was owned by Perma Patch, a company separate from his own. I asked whether the land on which the building is located is owned or leased by Perma Patch and was told it is not. It would be unusual for a company to erect a building on land owned by another party with no long-term lease. Nevertheless, if the building belongs to a separate company that is buying material from the mine and processing it into a product, I did not think it should be included as art of the mine disturbance and so did not take GPS data for the building area.

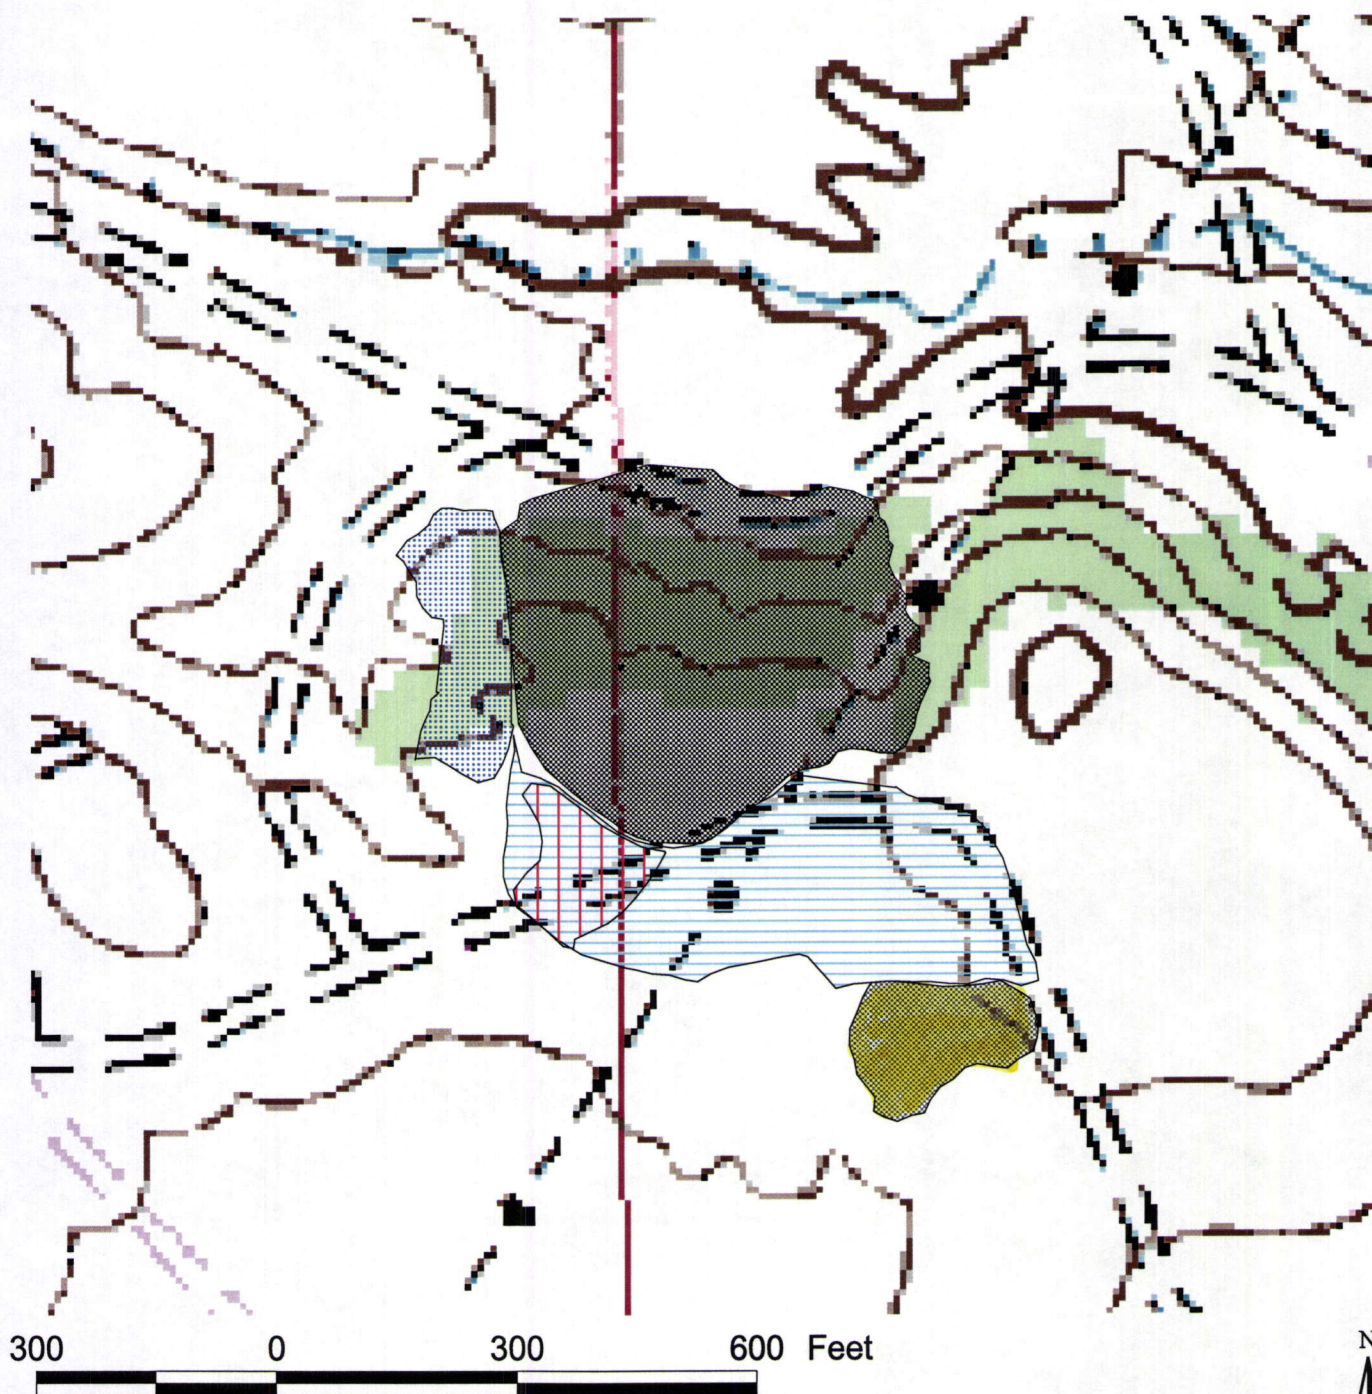
# Wembco Mine S/047/068

- Processing, 2.93 acres
- Mixing area, 0.48 acres
- Reclaimable area, 0.76 acres
- Recycling area, 0.64 acres
- WEMBCO Mine, 4.38 acres

Map created June 6, 2003, from data gathered by Paul Baker May 22, 2003. Vernal NW Quad, Township 4 South, Range 20 East, Sections 23 and 24, SLBM.

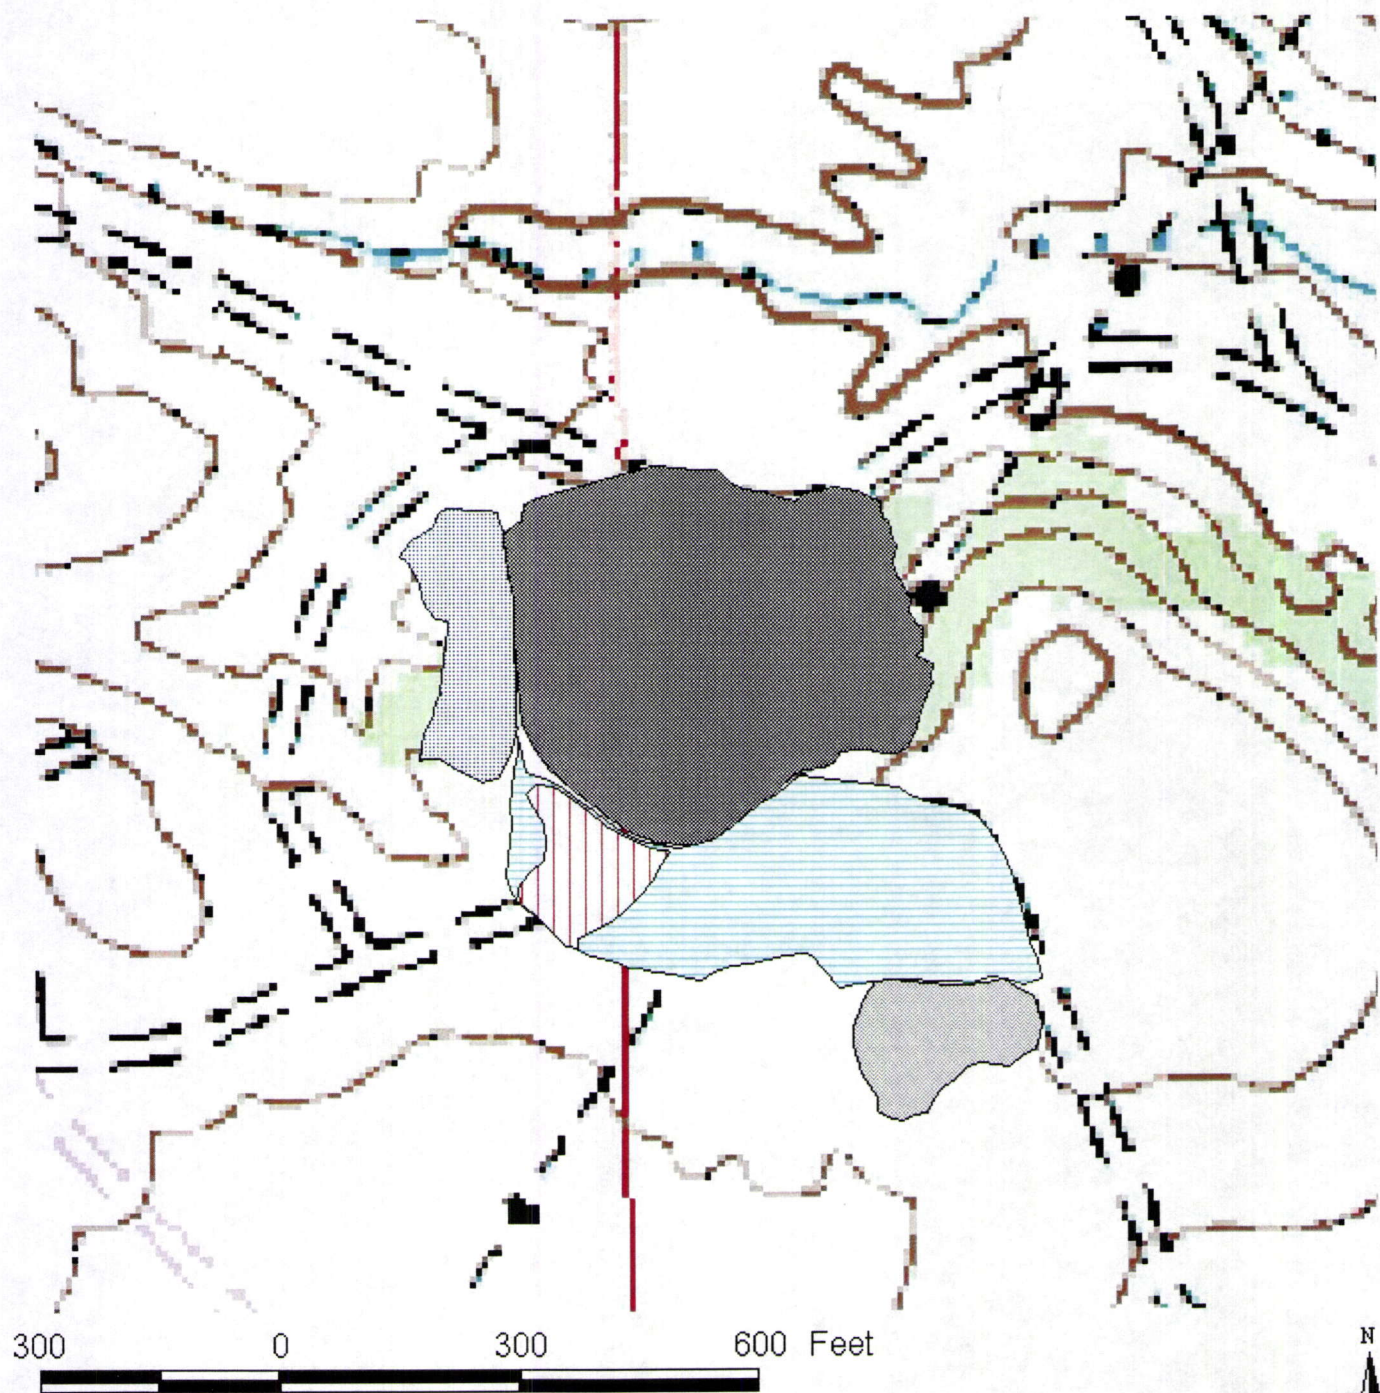
# Wembco Mine S/047/068

- Processing, 2.93 acres
- Mixing area, 0.48 acres
- Reclaimable area, 0.76 acres
- Recycling area, 0.64 acres
- WEMBCO Mine, 4.38 acres

Map created June 6, 2003, from data gathered by Paul Baker May 22, 2003. Vernal NW Quad, Township 4 South, Range 20 East, Sections 23 and 24, SLBM.
